# X353-5B PROPULSION SYSTEM FLIGHTWORTHINESS TEST REPORT

LIFT FAN FLIGHT RESEARCH AIRCRAFT PROGRAM

CONTRACT DA 44-177-TC-715

GENERAL ELECTRIC COMPANY

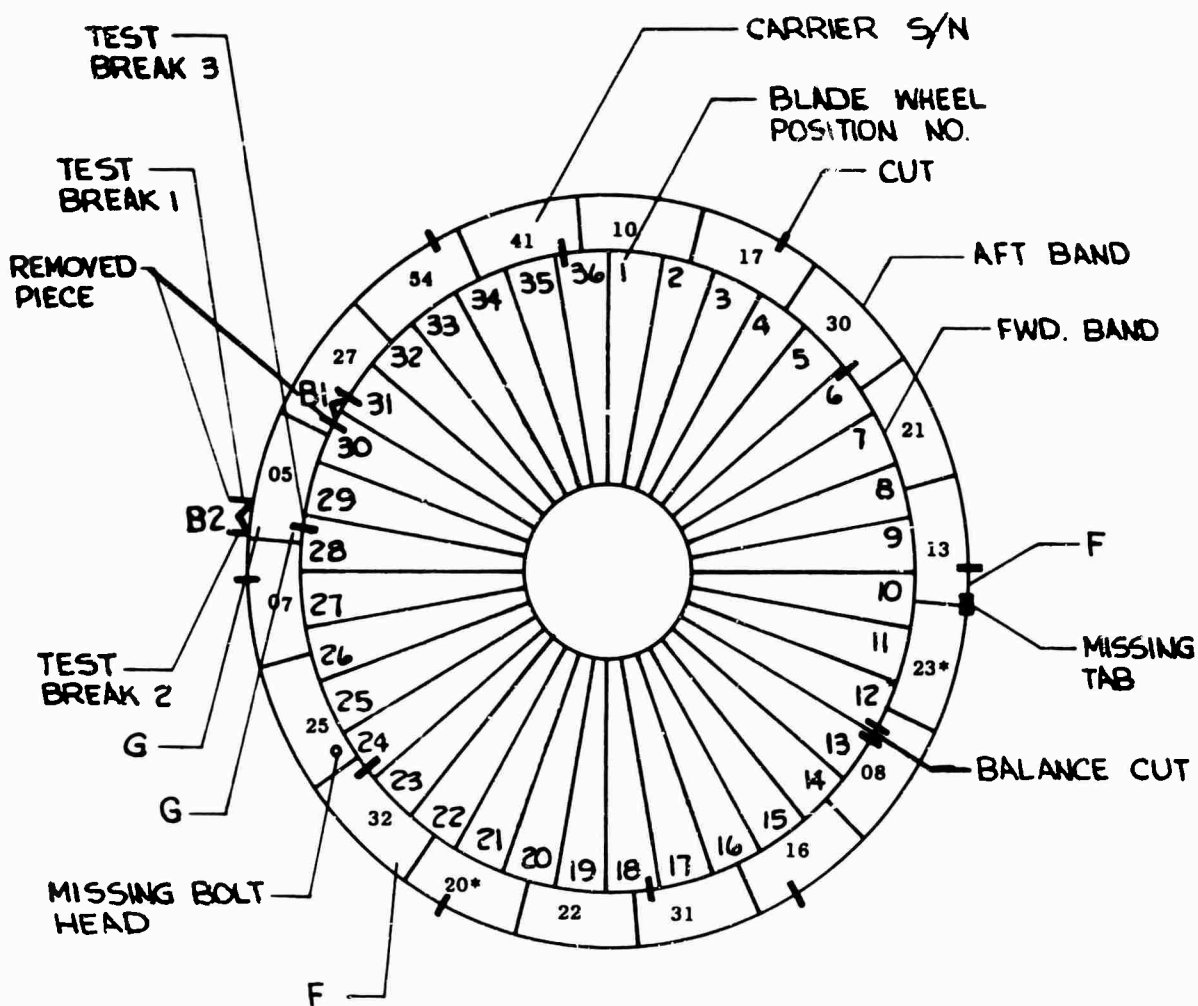
Figure I-66. Lift Fan Rotor Configuration and Test Incident Schematic

There were only minor discrepancies found in the diverter valve and pitch fan hardware at disassembly. The lift fan had considerable damage resulting from the shedding of a small metal tab from the rotor during the last endurance cycle of the test. Lift fan aluminum inlet vanes and exit louvers were of generally poor manufacturing quality and did not satisfactorily complete the test.

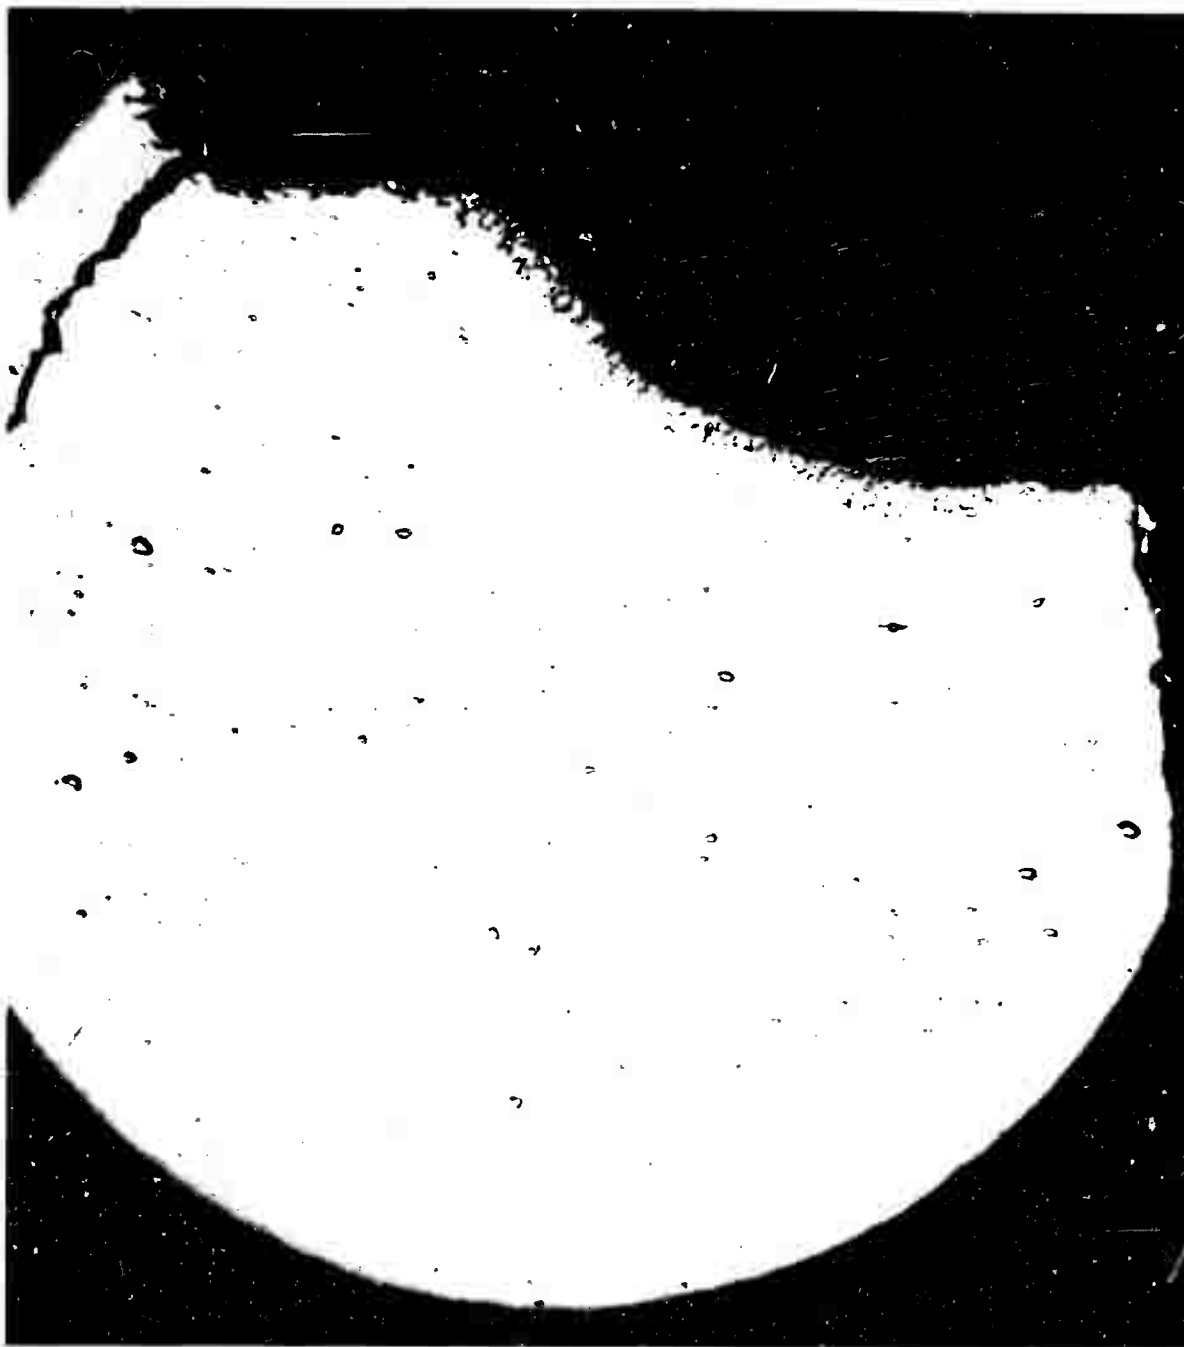
The surface condition appearance in the radius under 250X magnification is normal and is not considered a notched condition. Note the secondary crack in Figure I-68.

Figure I-68 250X Microscopic Examination of One Failed Bolt  
at the Head to Stem Radius. (Sectioned)

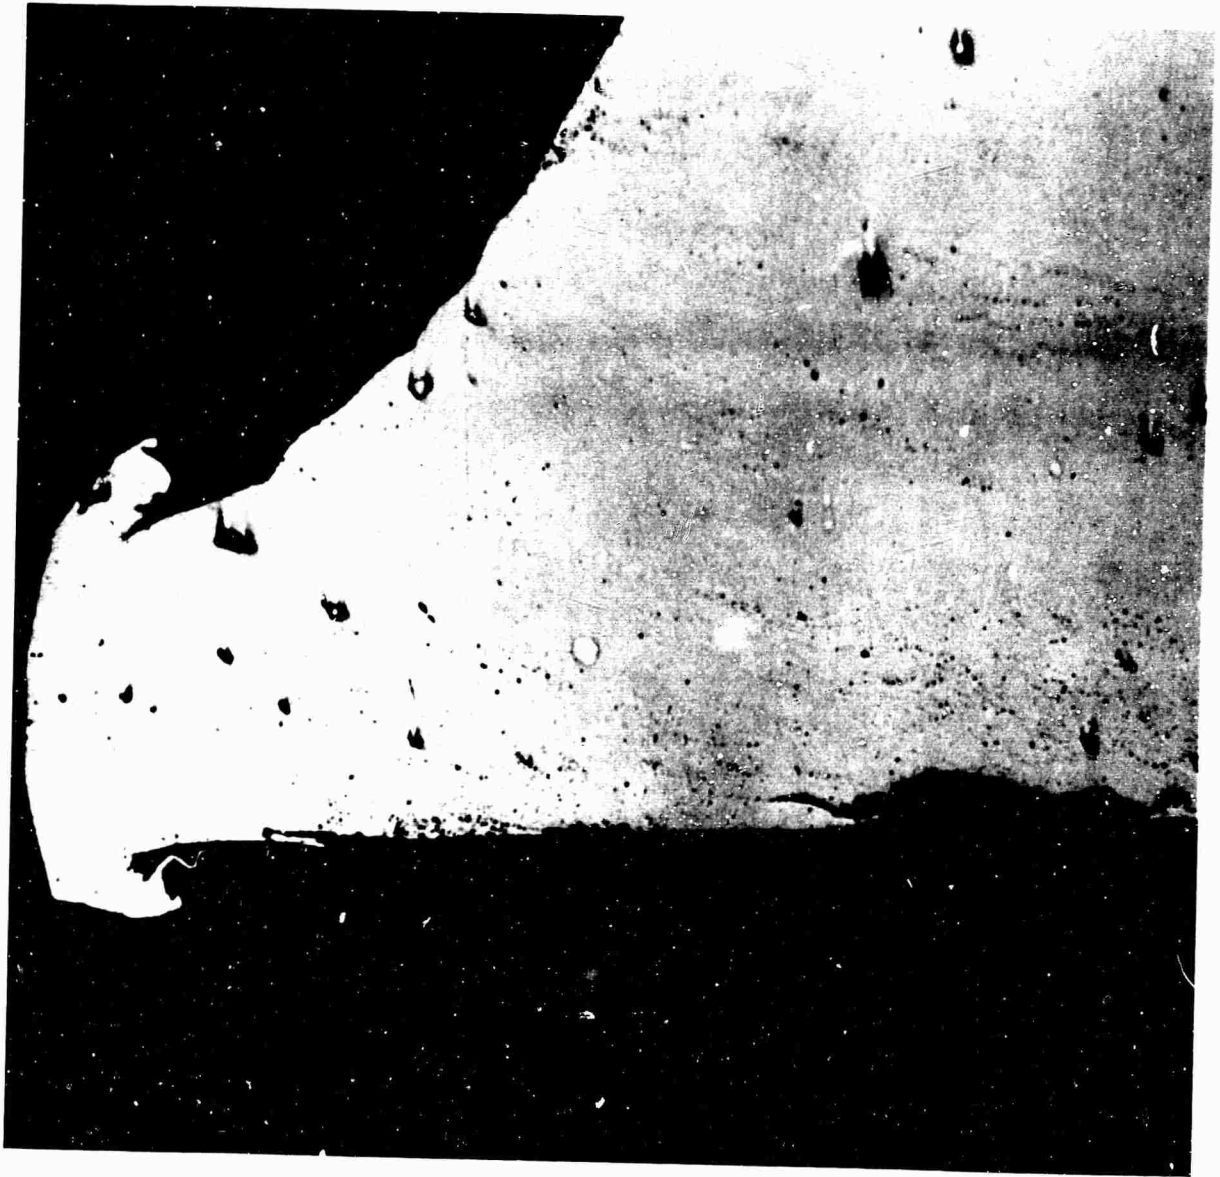
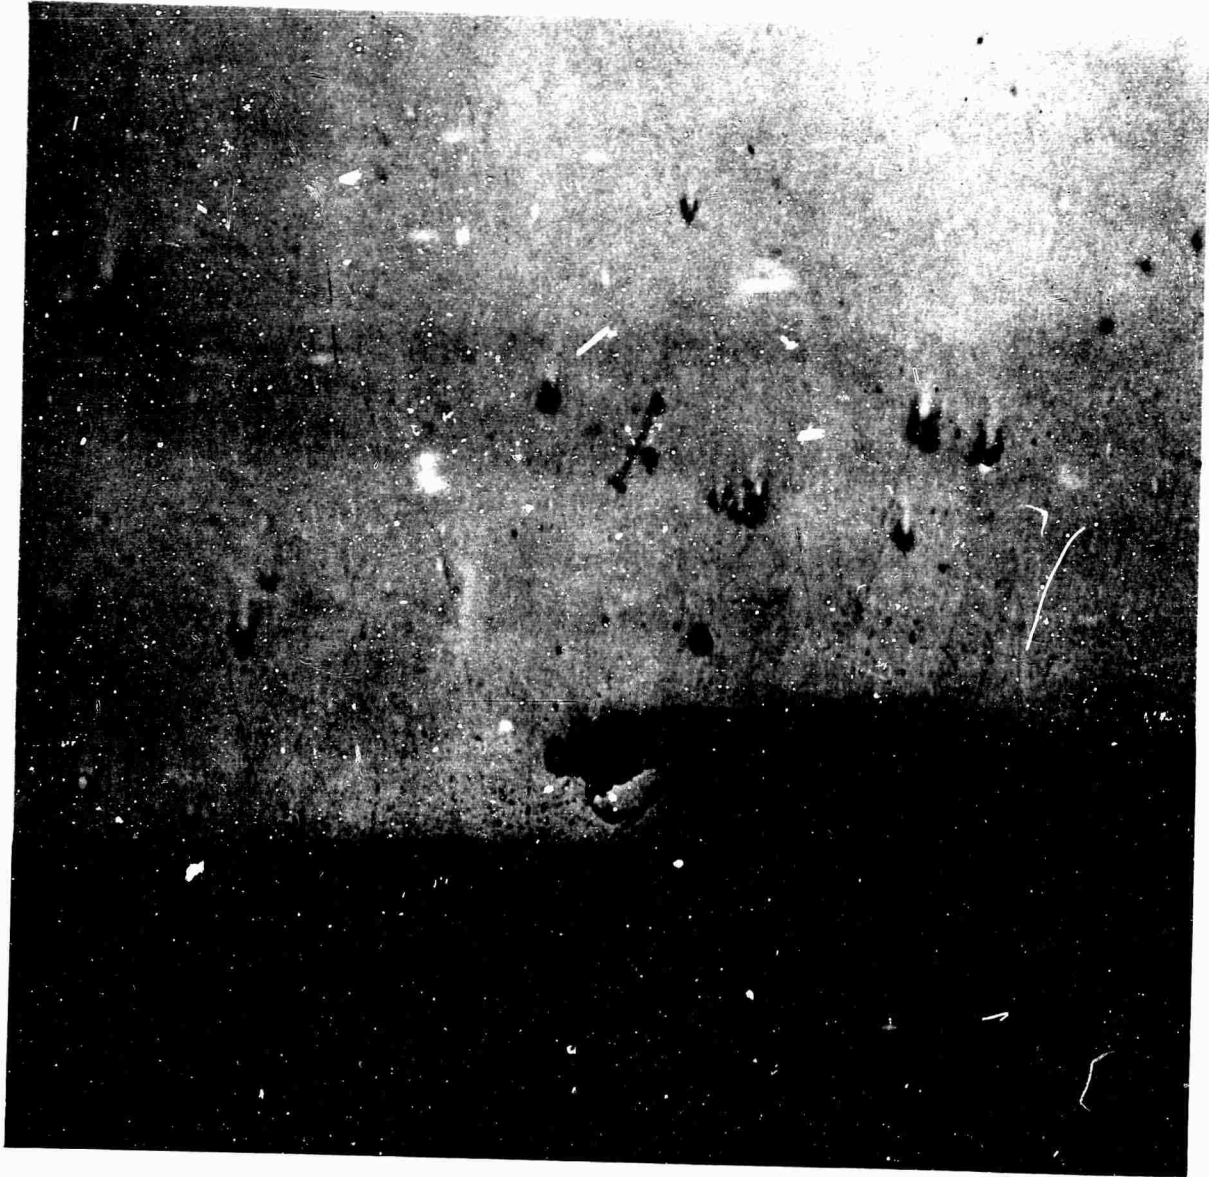
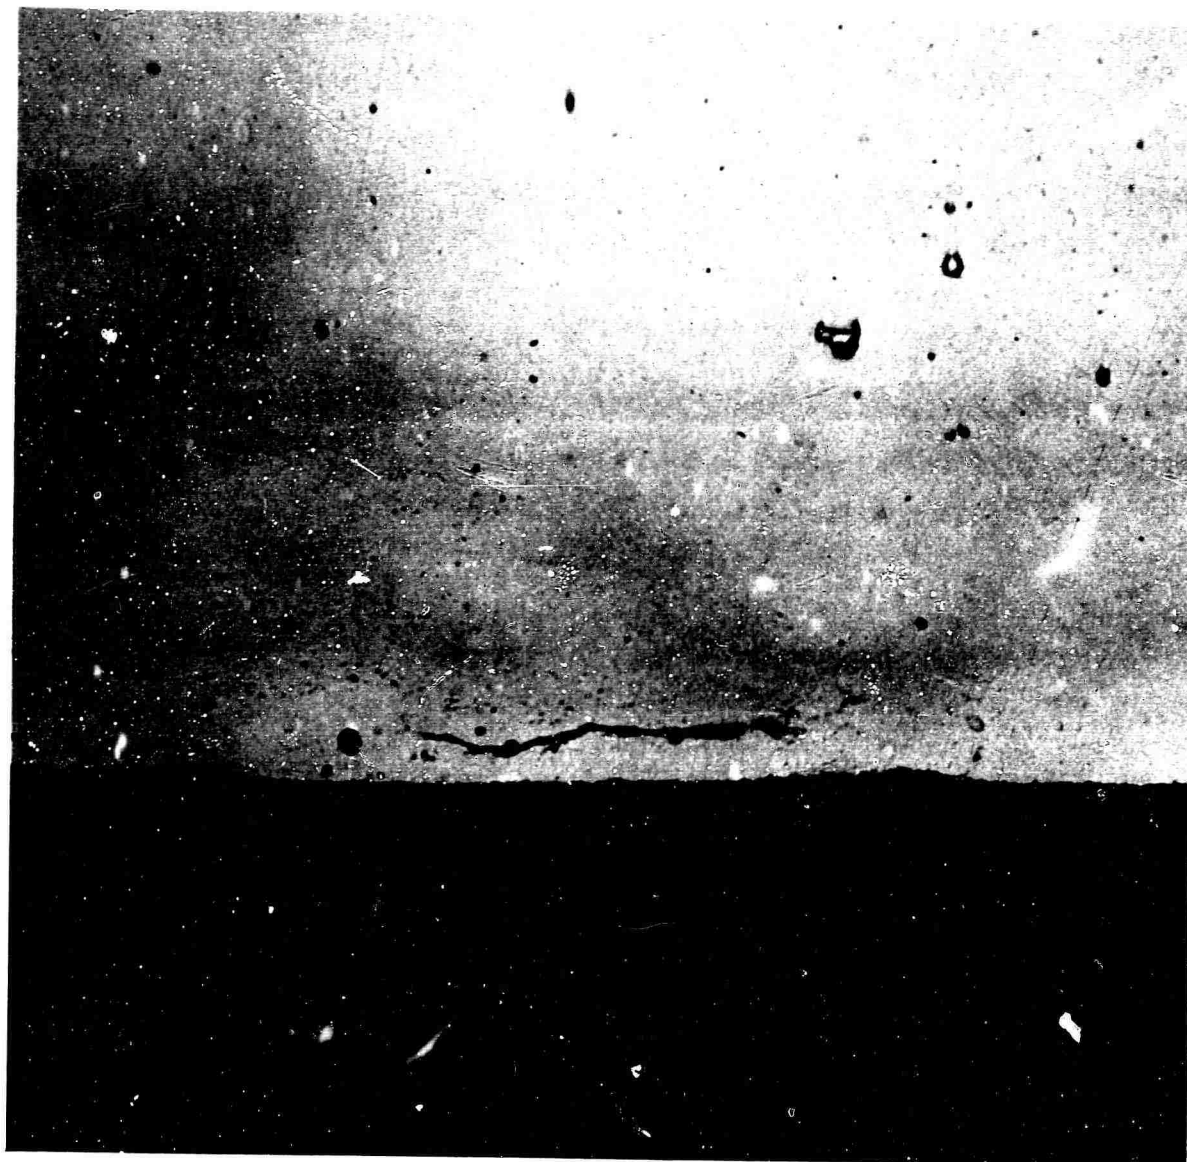
If the fretting exposes a non-metallic inclusion to the surface the combined effect is much more severe than the inclusion or fretting alone.

Figure I-71 A, B, C, D, E, and F. 500X Microscopic Examination of Torque Band Failure (Test Break No. 3) - Progressive Views Across the Failure

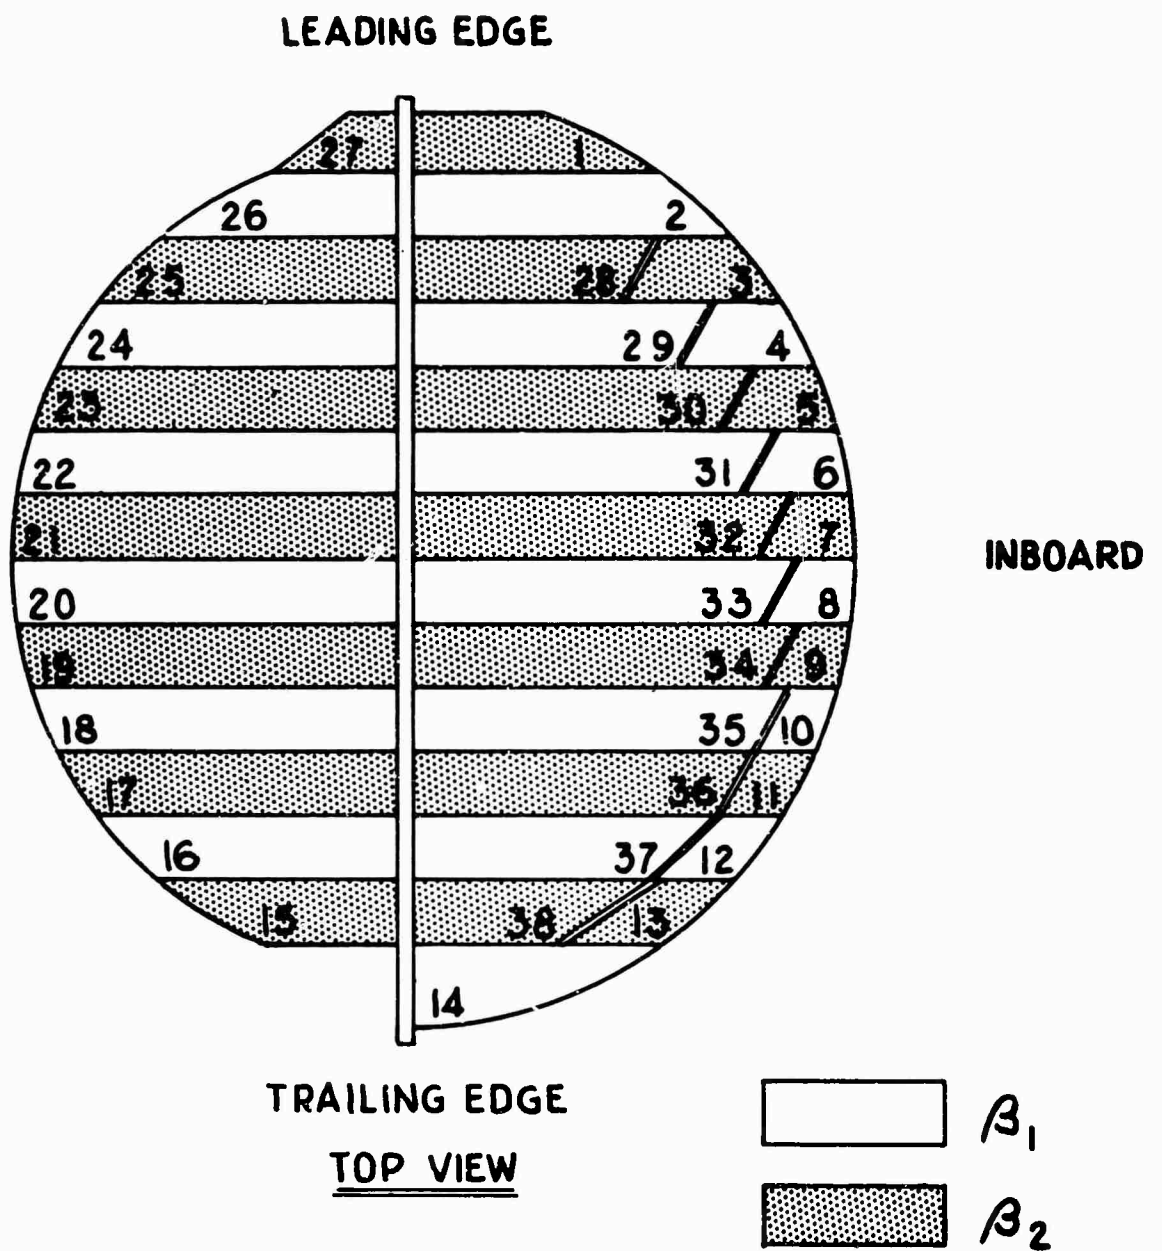
Figure I-74. Lift Fan Exit Louver Arrangement (Left Fan)

1. All Inconel X louvers completed the FWT without test fault.
2. Ten of 22 aluminum louvers completed the FWT without test fault.
3. Over 80% of the repairs were required to louvers on the inactive arc half of the fan.
4. Four louvers required replacements.
5. The frequency of repair incidents was one every 4.17 hours.
6. The average time between repairs for a given louver was 17.57 hours.

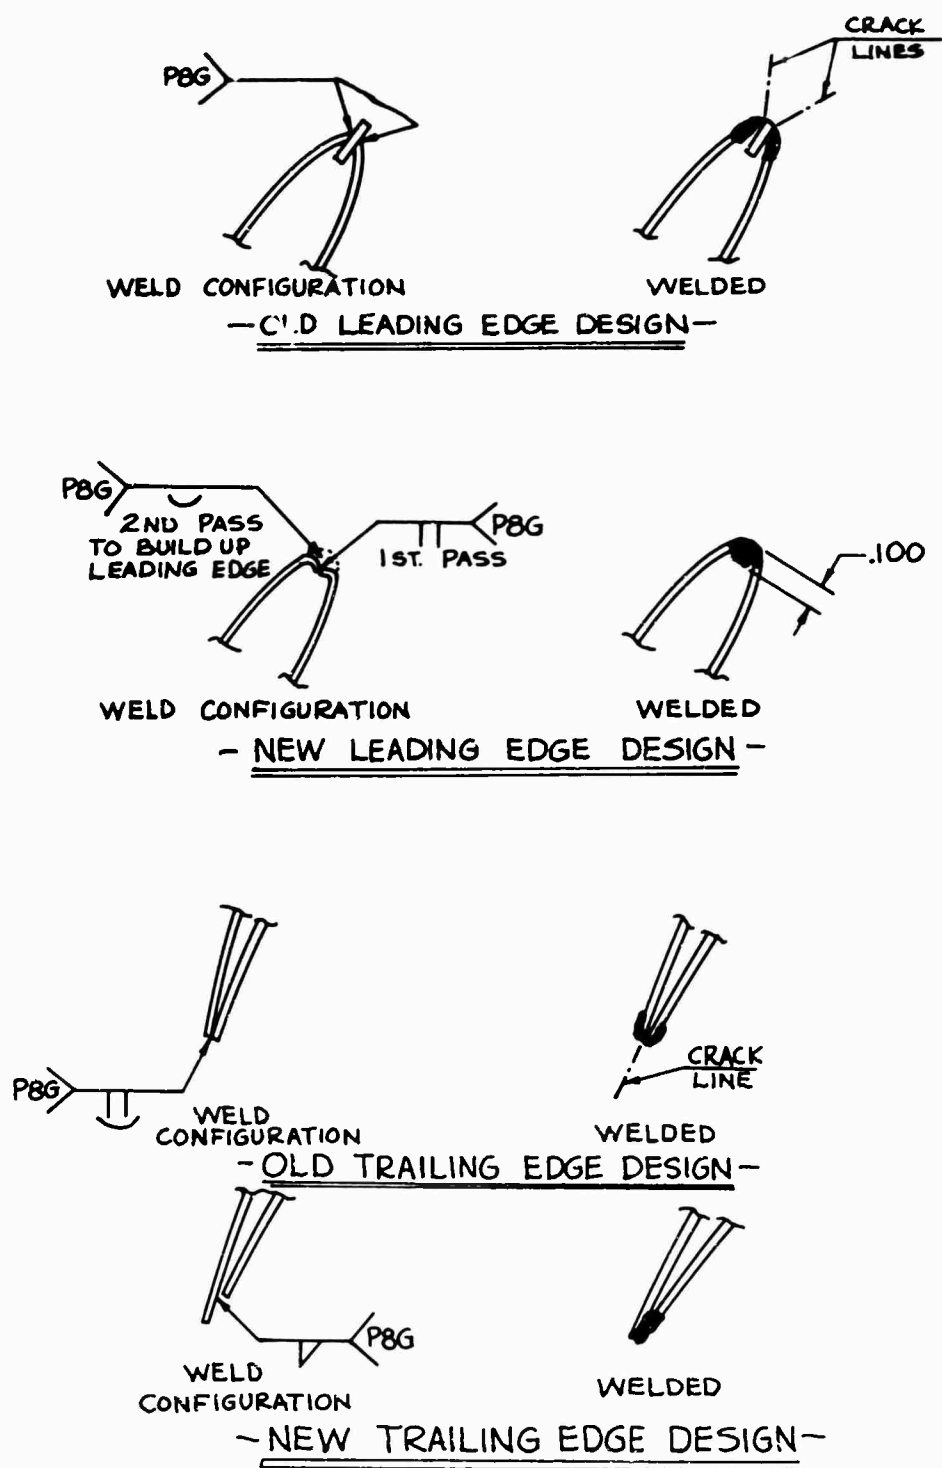
Figure I-75. Lift Fan Inlet Circular Vane Leading And Trailing Edge Weld Design Change

- 1. Development of improved aluminum cleaning processes for preparation for spot welding.
  - 2. Establishing better process control to insure spot weld operation within desirable time limit after parts cleaning.
